Limited Visual Dam Safety Inspection Summary Report

MA-088

HC&S Reservoir 84

May 2006

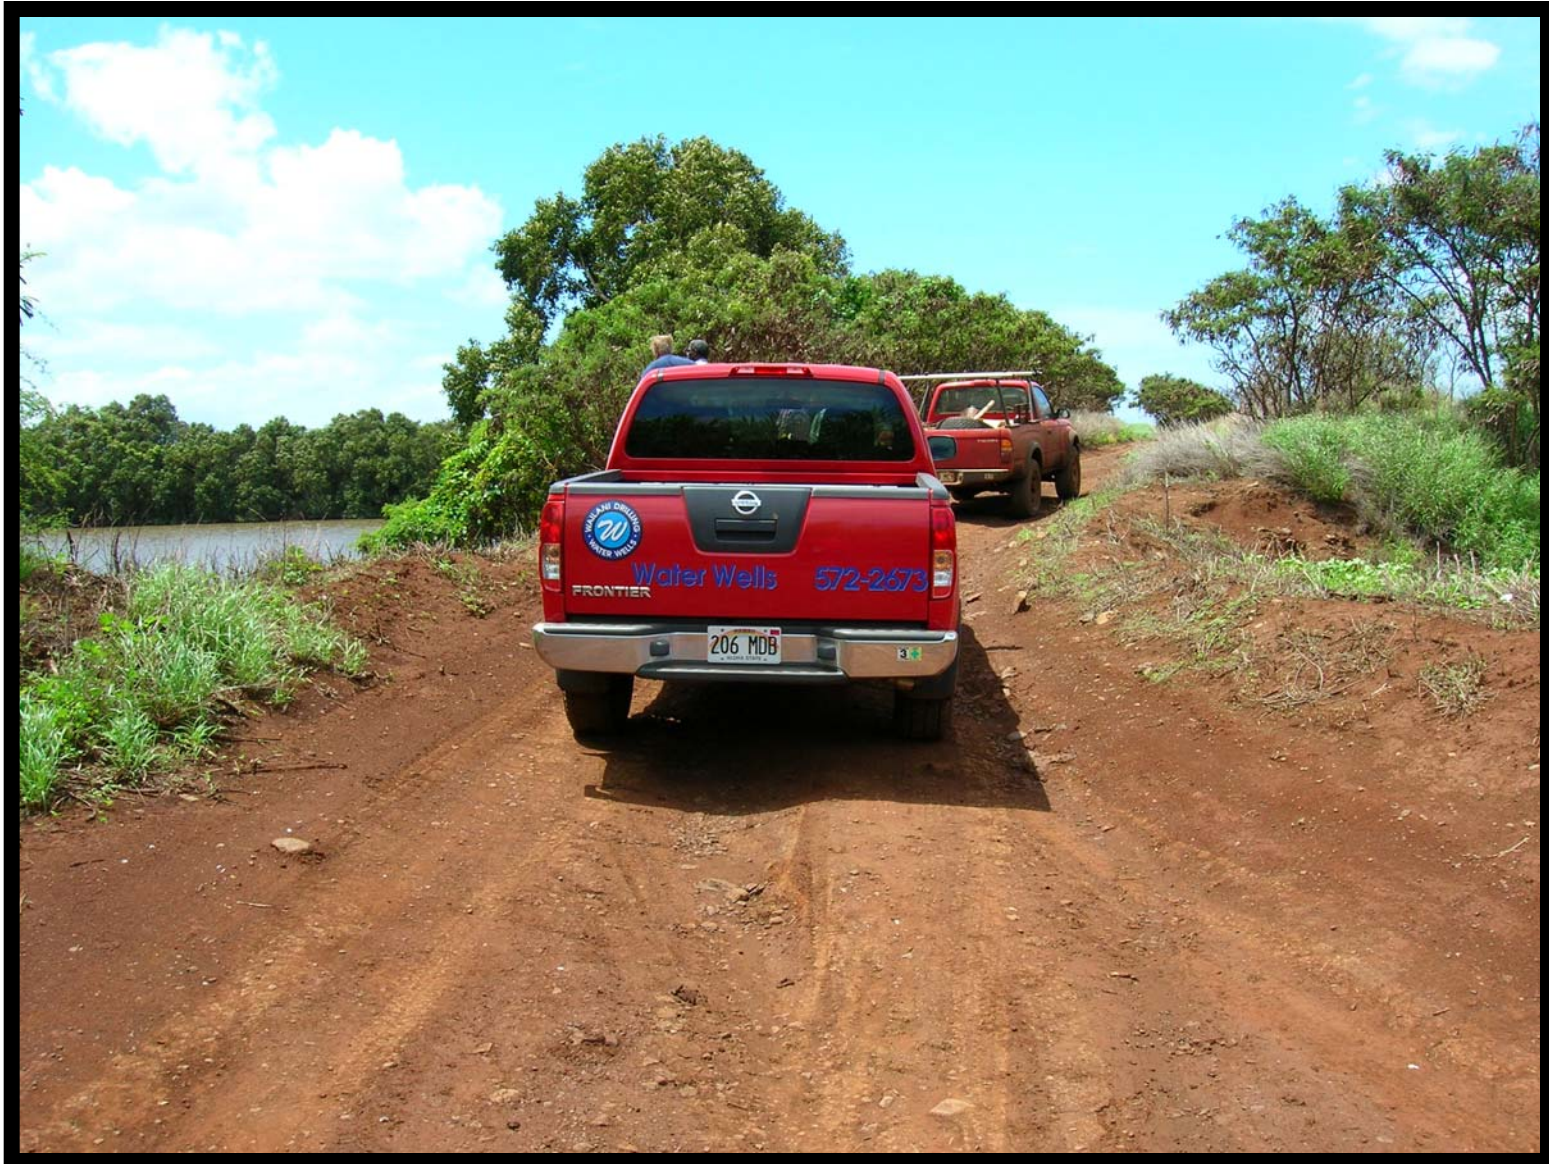
088 crest

- a. The dam crest appeared to be in satisfactory condition and requires no corrective action.
- b. Access along the crest was satisfactory.

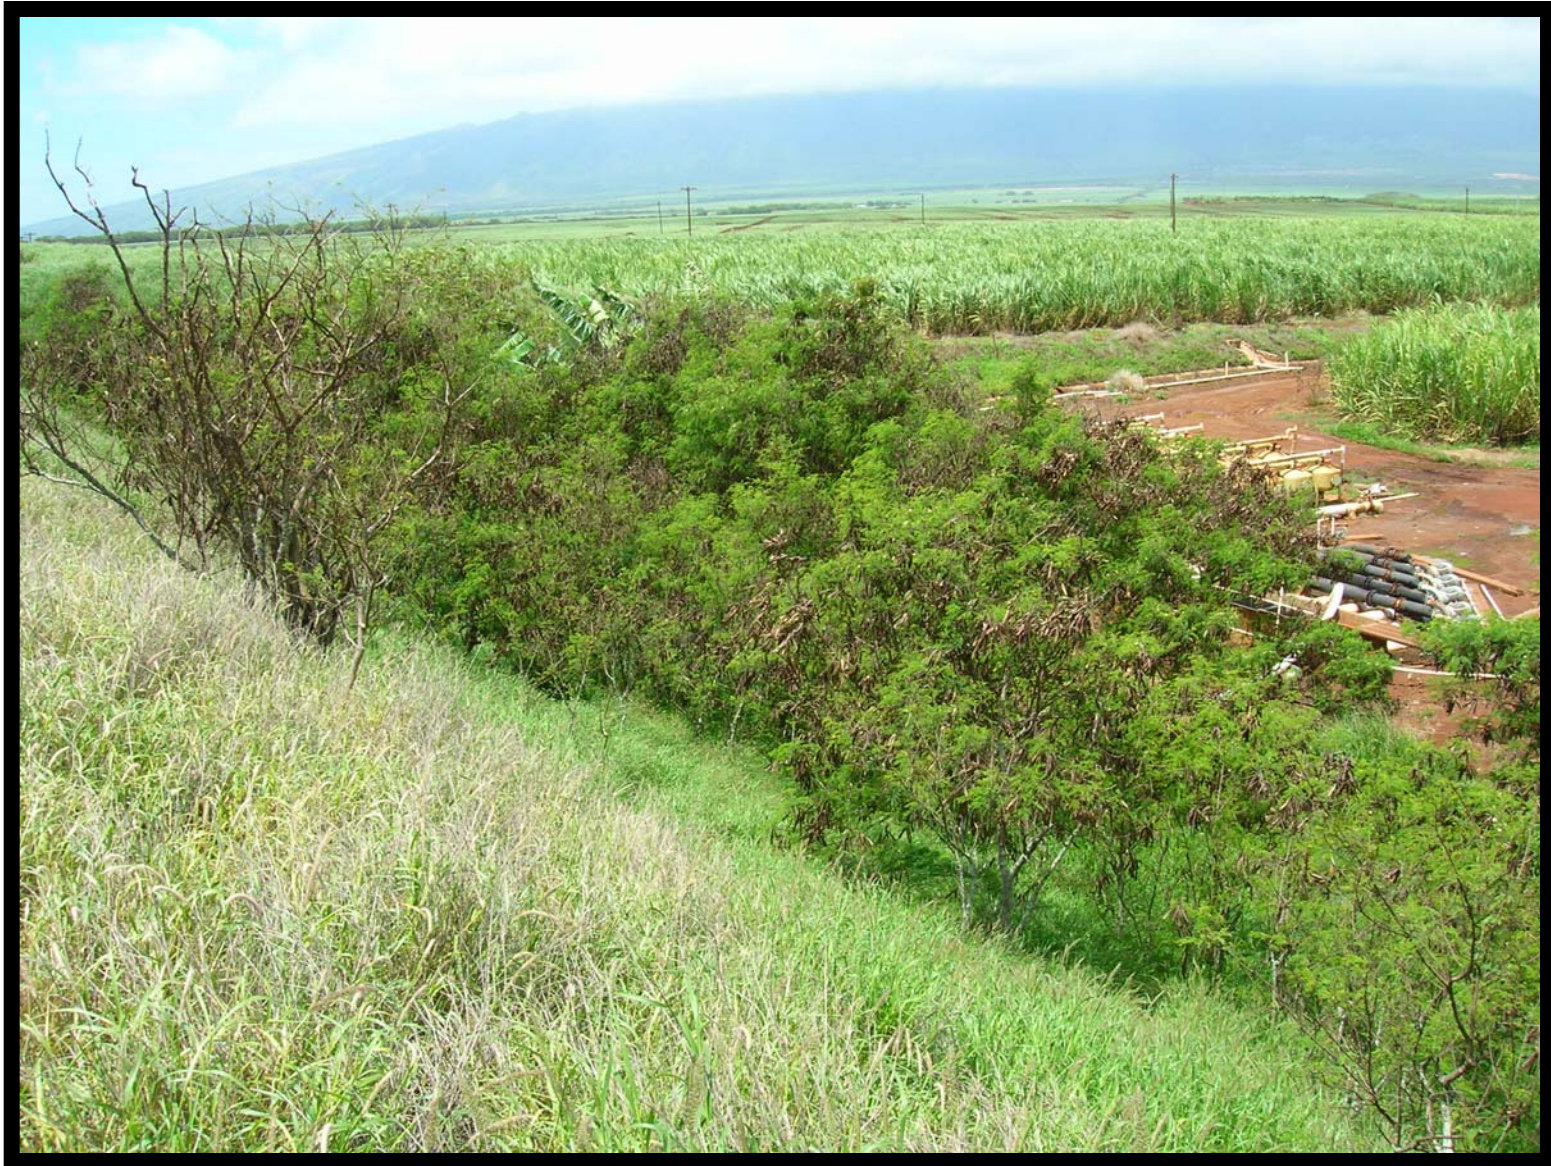
088 downstream slope

The downstream slope was in fair to poor condition and not visible due to heavy vegetation. The slope was very steep, around a 1 on 1.5 slope.

Erosion was noted in a large gully about 3' wide near the crest. The slope was not entirely visible due to vegetation.

Tall grass, bushes and trees were observed on the downstream slope.

- a. The downstream slope appeared to be in fair to poor condition and requires corrective action.
- b. The down stream slope was not visible due to high grass and bush vegetation. Clear high vegetation and maintain low to enable easy visual inspection.

- c. Tree(s) were observed on the downstream slope. Trees have been identified as the probably cause of piping failures, and can possibly cause sever damage to the embankment if they are uprooted during a high winds. Corrective action is required to remove the tree hazards from the dam. Acceptable remedies include removal of the tree and its root structure down to a 2" diameter and reconstructing the damaged embankment section. All repair work shall be accomplished as per the requirements of licensed geotechnical or structural engineer. Routinely monitor the damaged area for signs of settlement and seepage.

- d. Rut and/or Gully erosion was observed on the slope, which requires maintenance and/or repair. Description: Fill gully with compacted fill
- e. Seepage/Ponding water was observed. Monitor and conduct further investigation to locate the source of water and extent of any possible hazardous or developing condition.

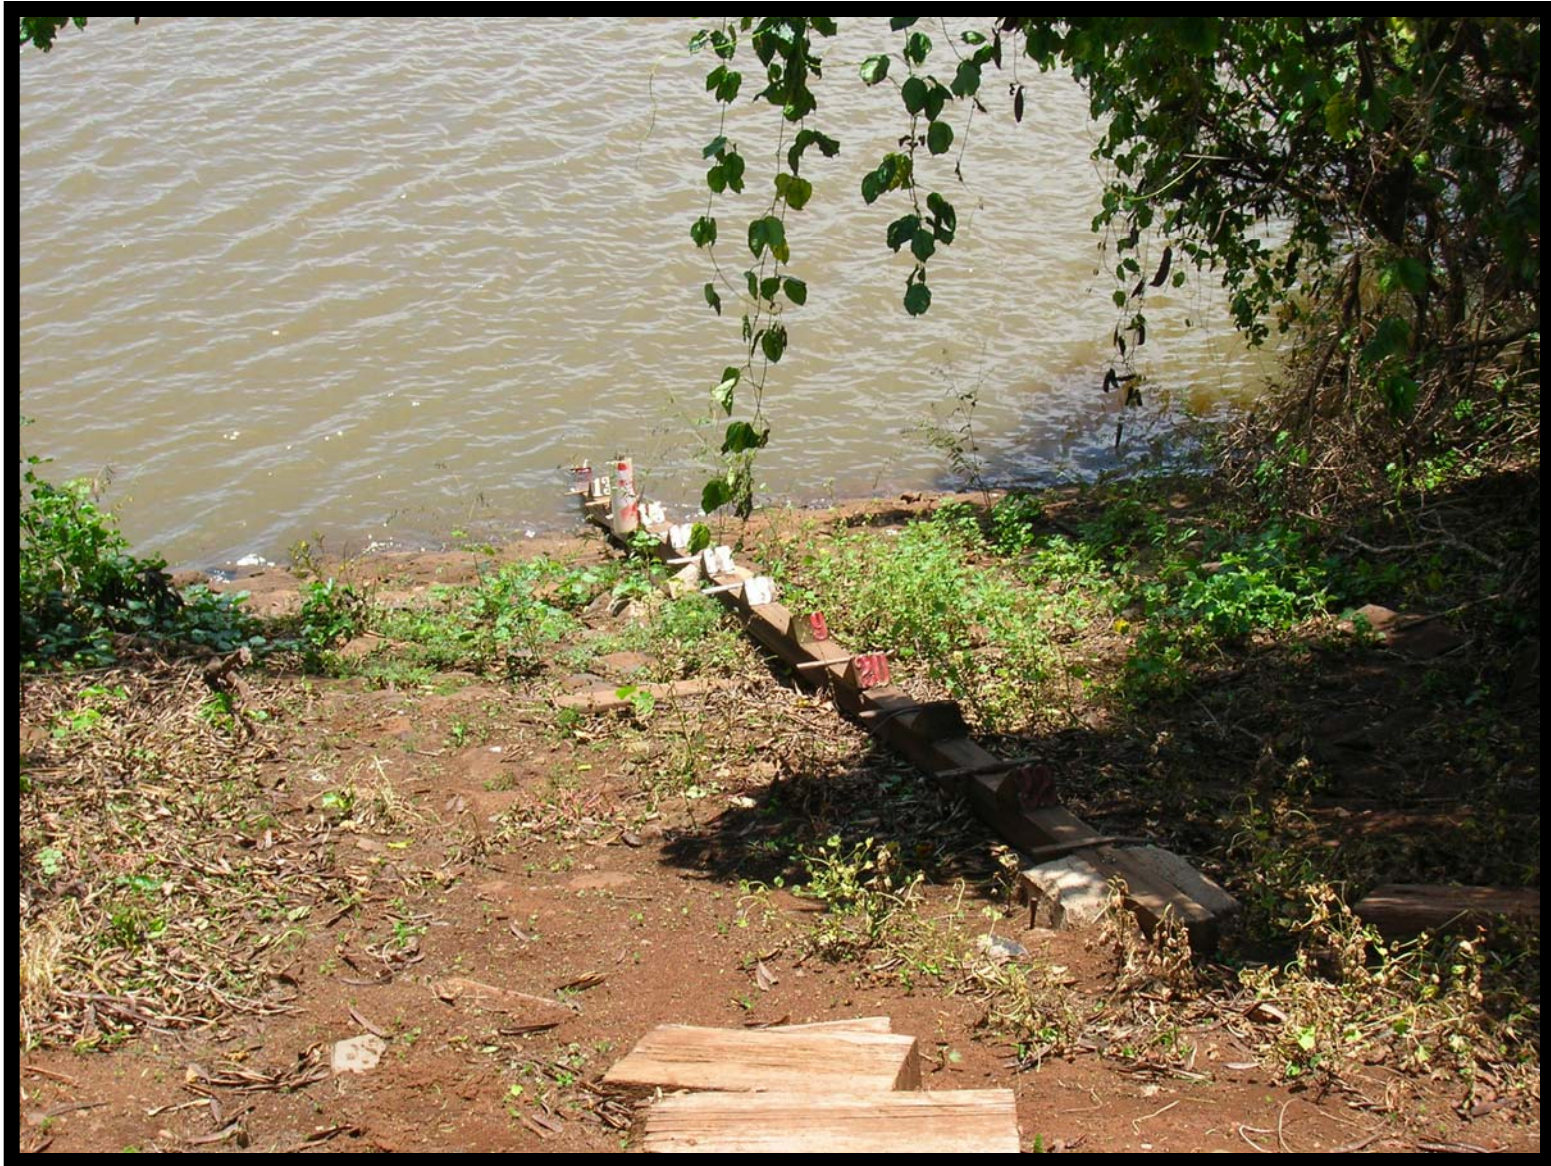
088 gage

A wooden staff gage was observed

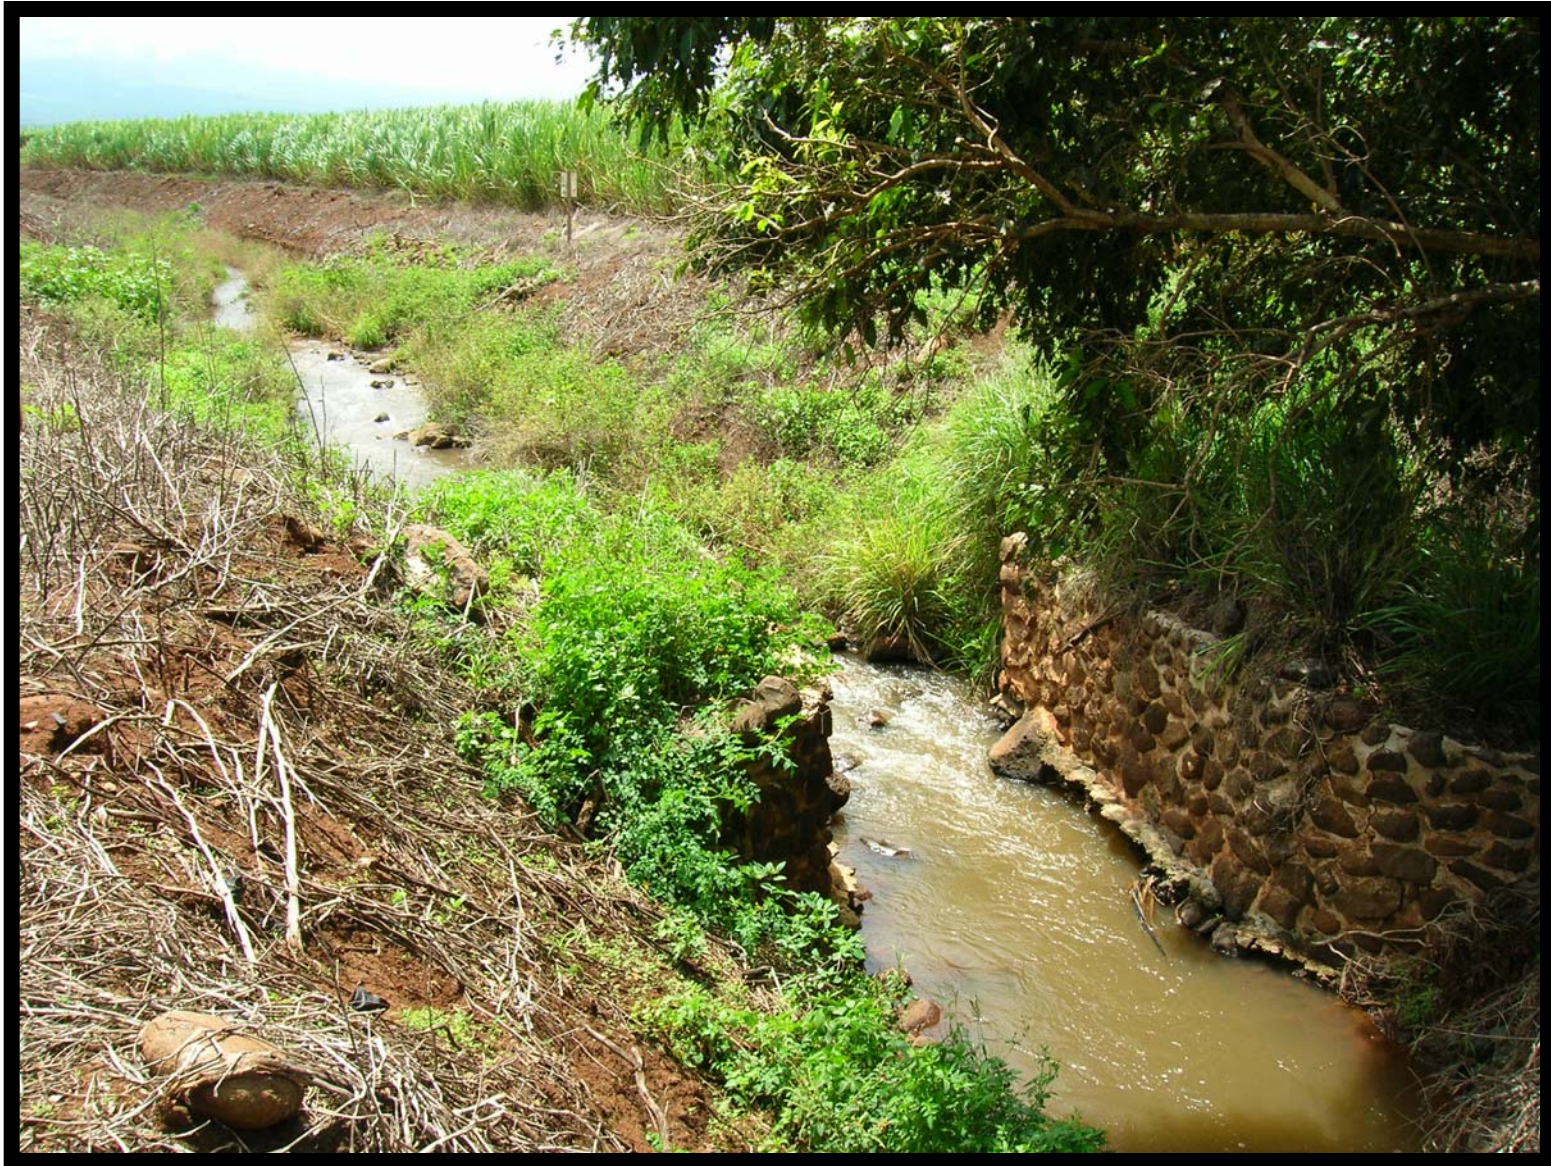
088 inlet

- a. The intake works were not tested.
- b. The intake works appeared to be in satisfactory condition, no corrective actions are required at this time.

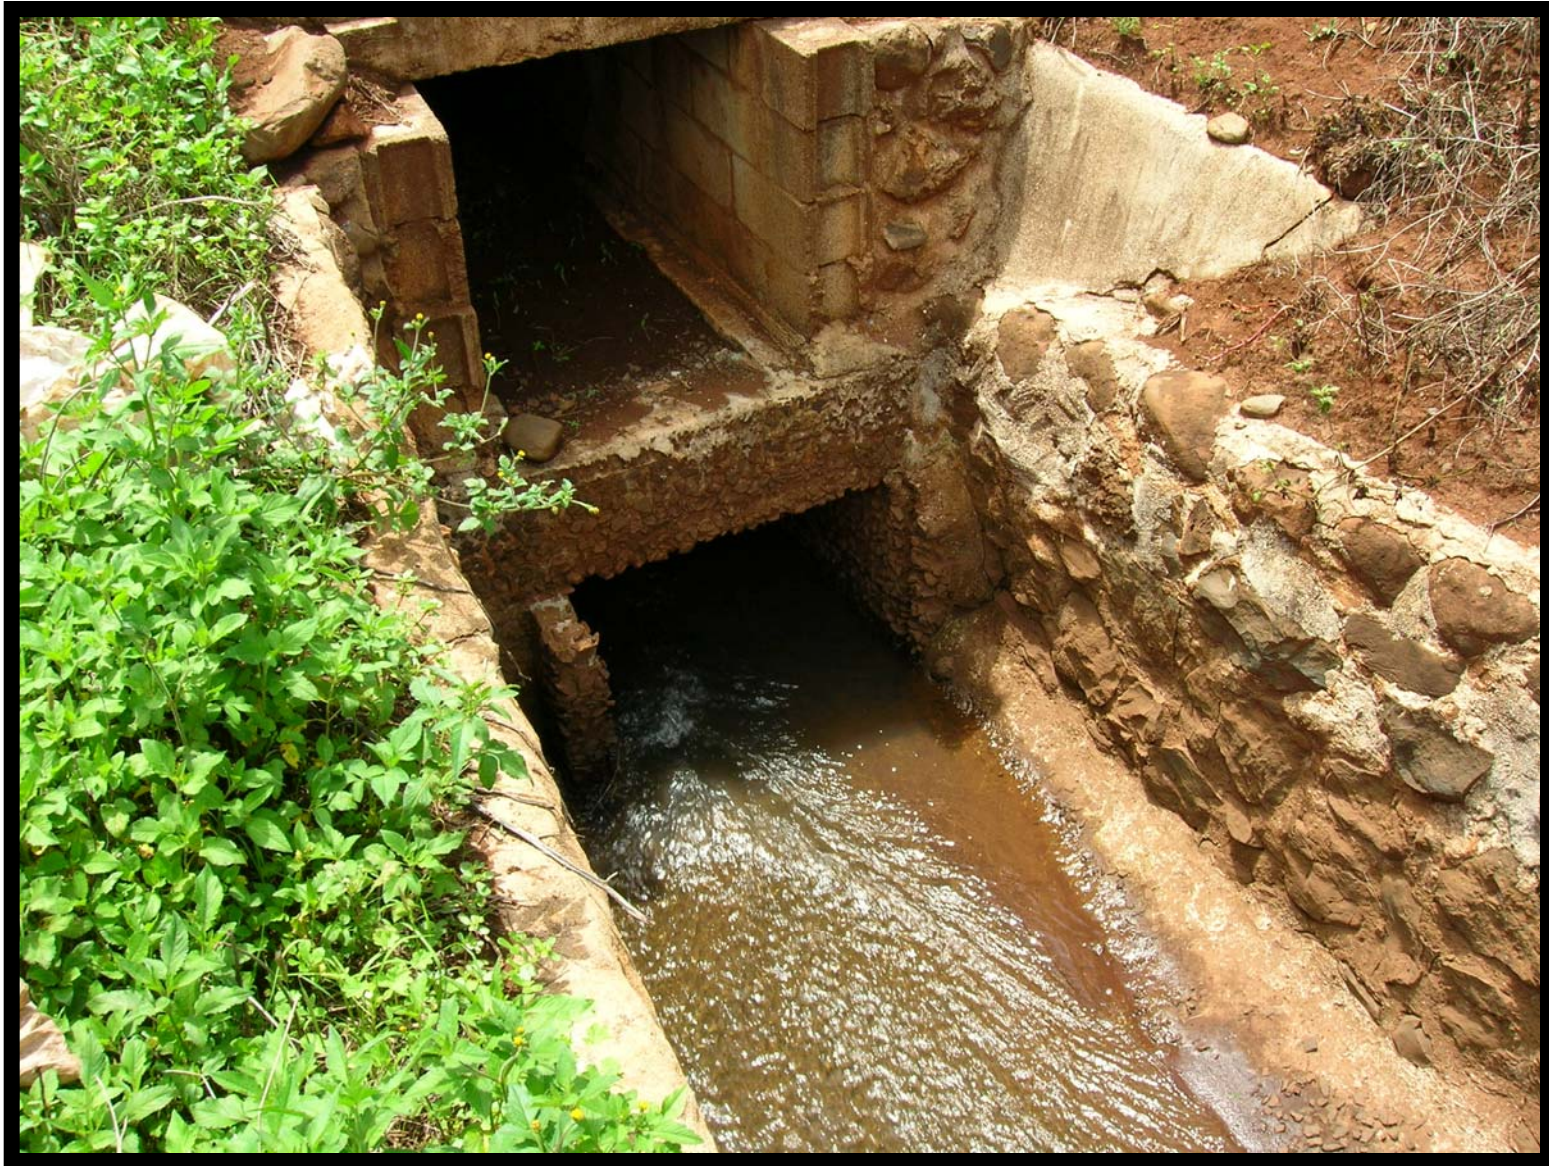
- a. The Spillway appeared to be in fair to poor condition and requires corrective action.
- b. Unclear if spillway is adequately sized. Spillway should pass the probable maximum flood. Verify spillway capacity and take corrective action as required.

088 inlet and spillway - 2nd Inlet (bottom) and spillway (top)

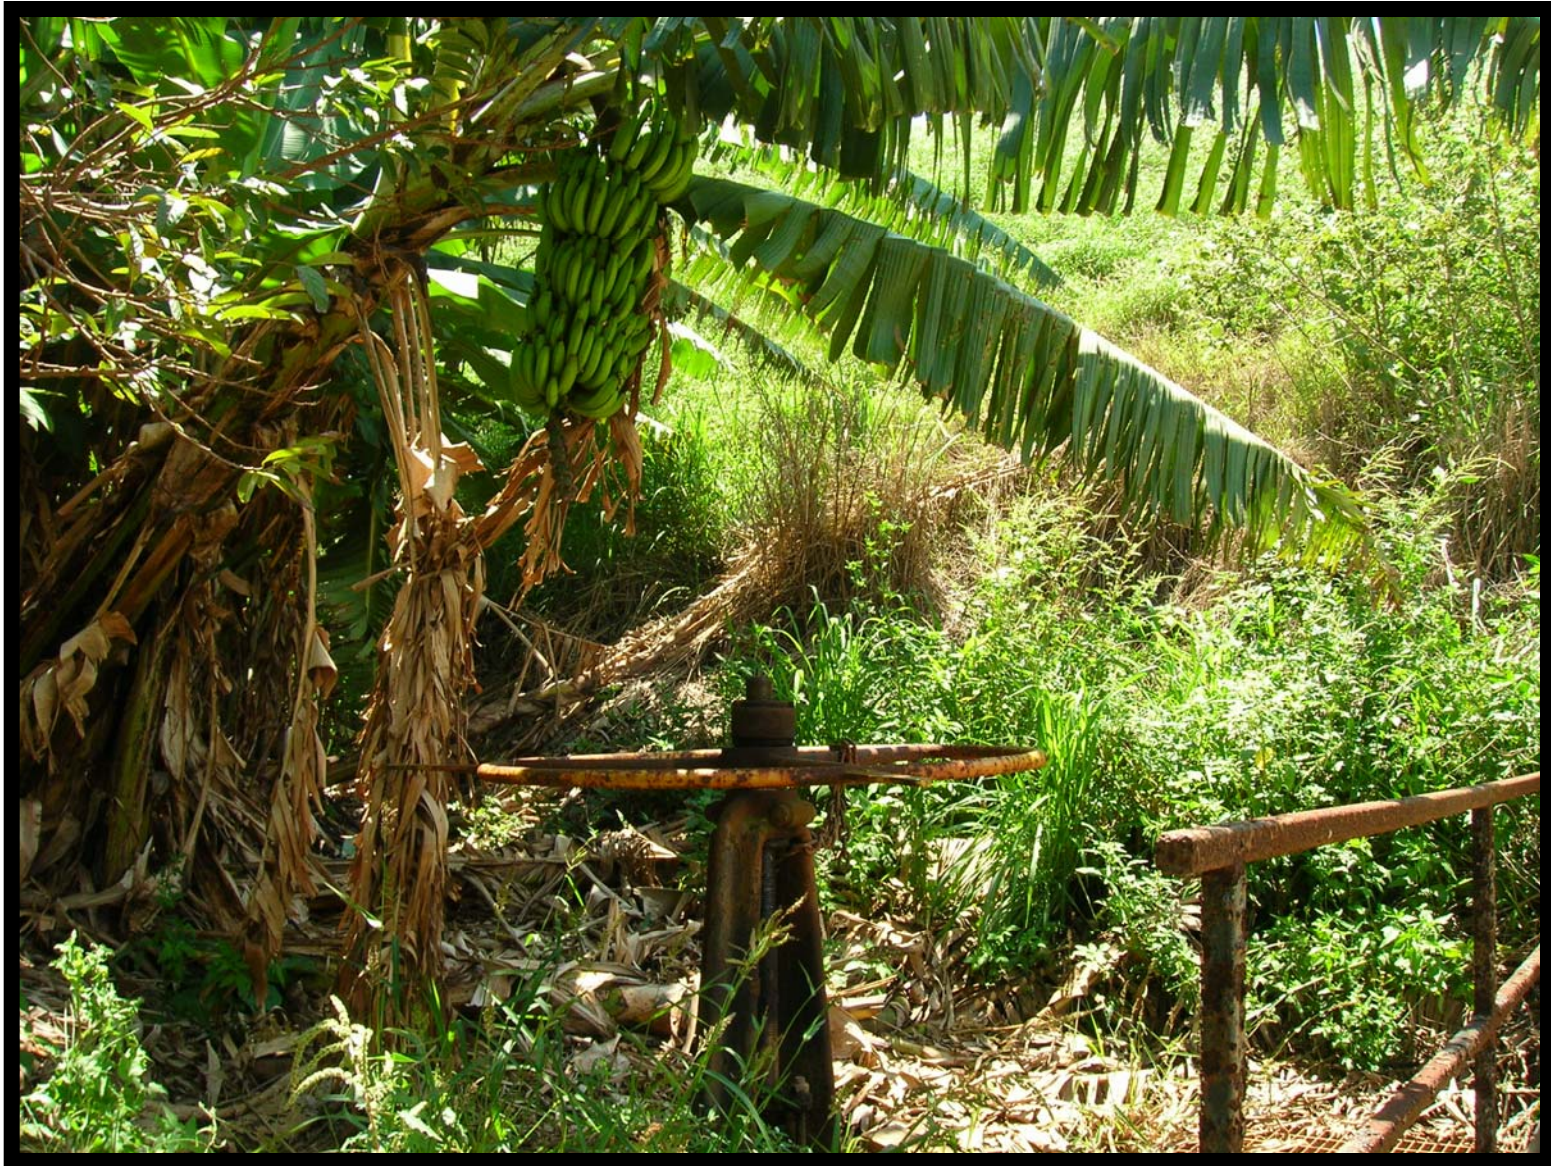
088 outlet valve

- b. The outlet works appeared to be in fair to poor condition, corrective actions are required at this time.
- c. Remove woody vegetation and roots near outlet.

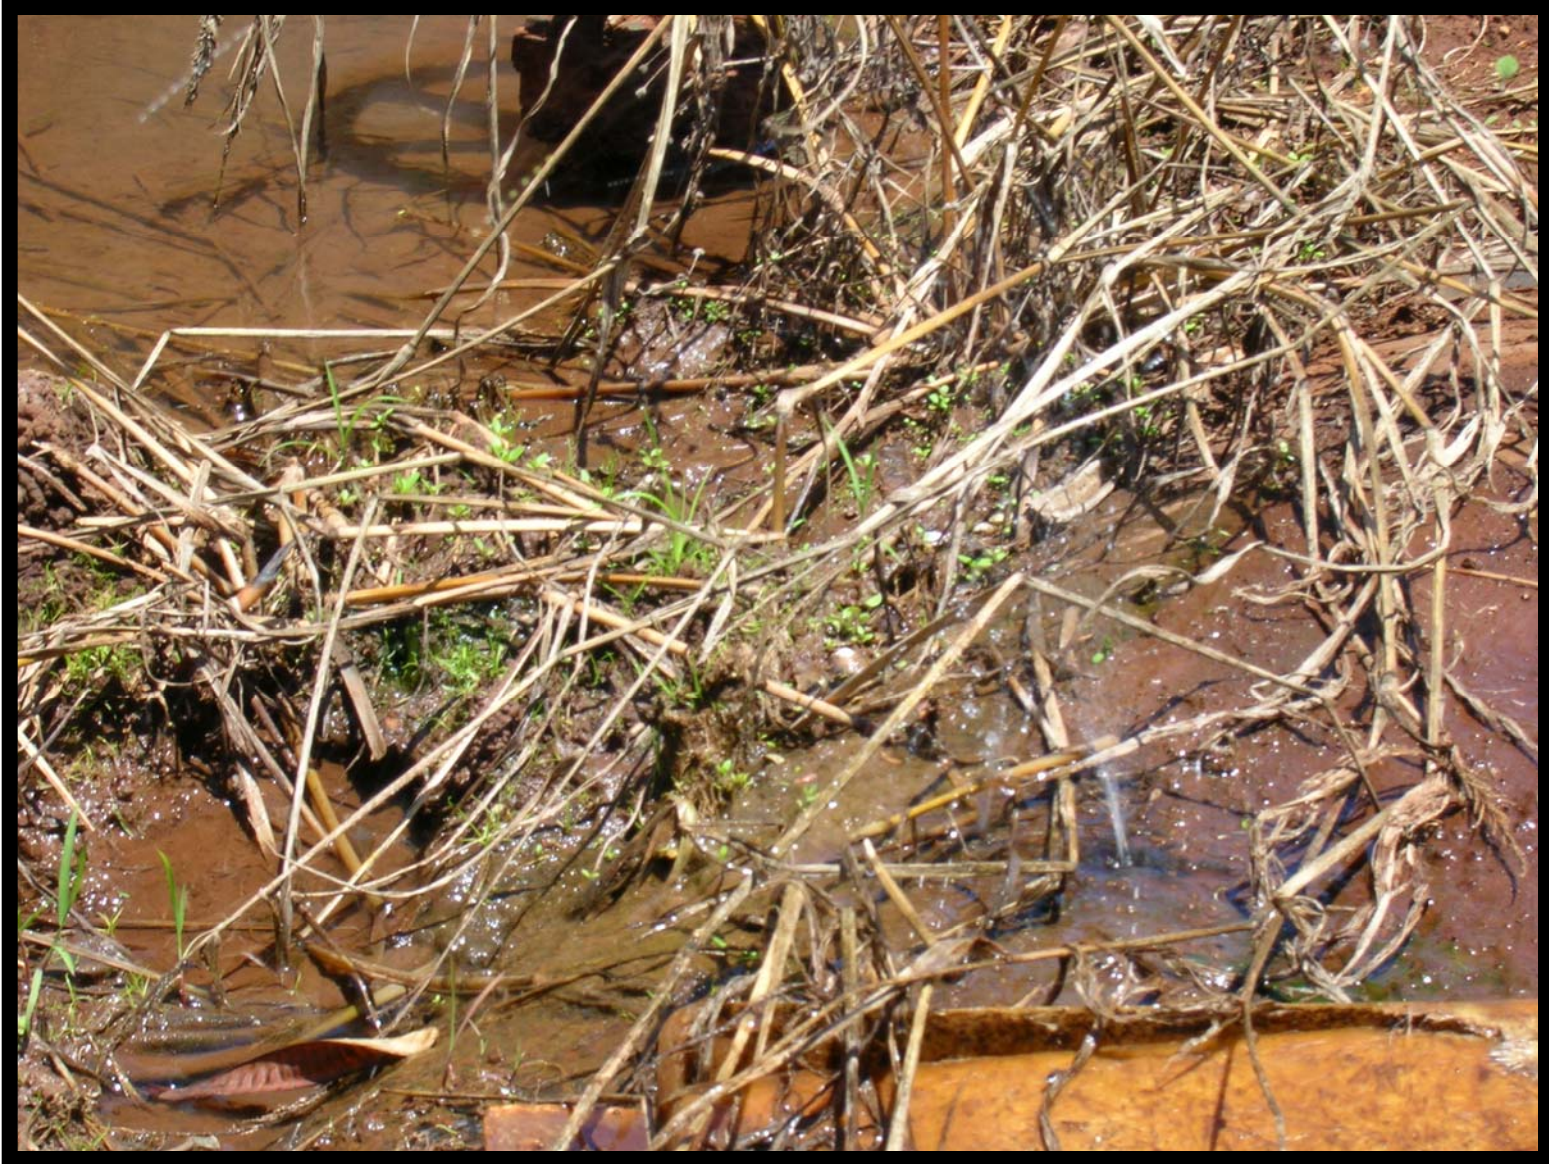
088 pipe leak - downstream near pumps

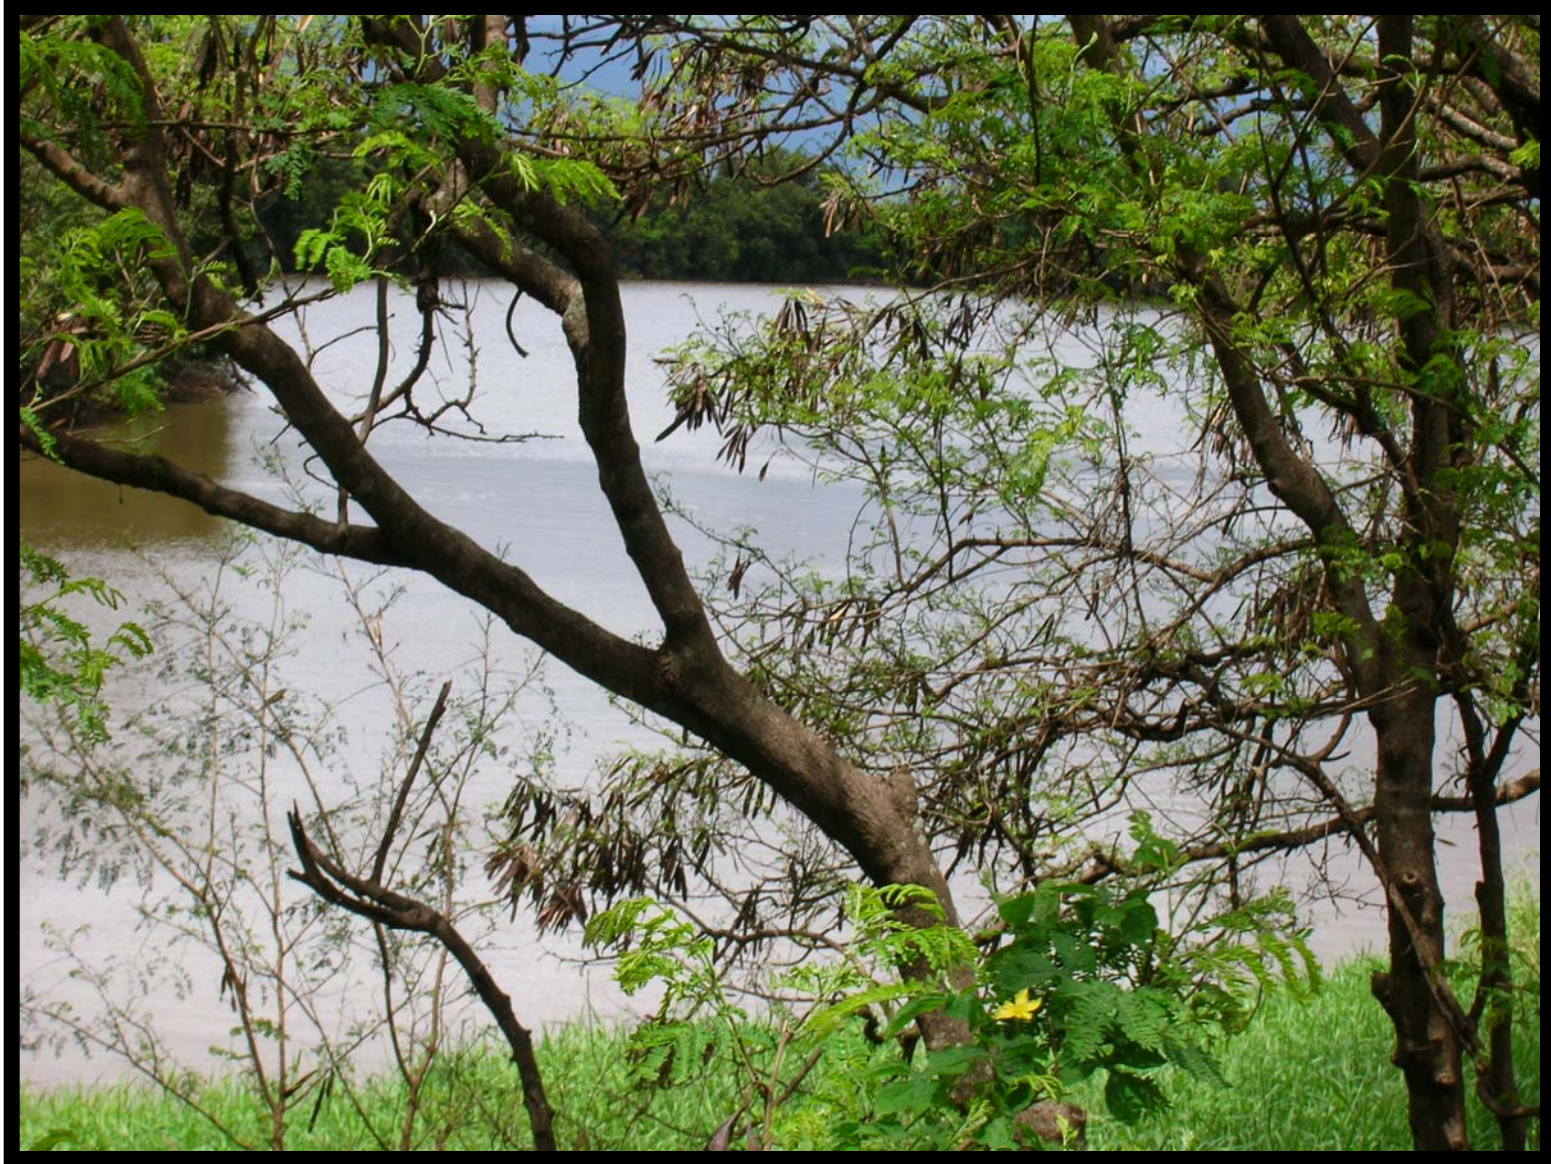
088 reservoir

- a. The reservoir appeared to be in satisfactory condition, no corrective actions are required at this time.

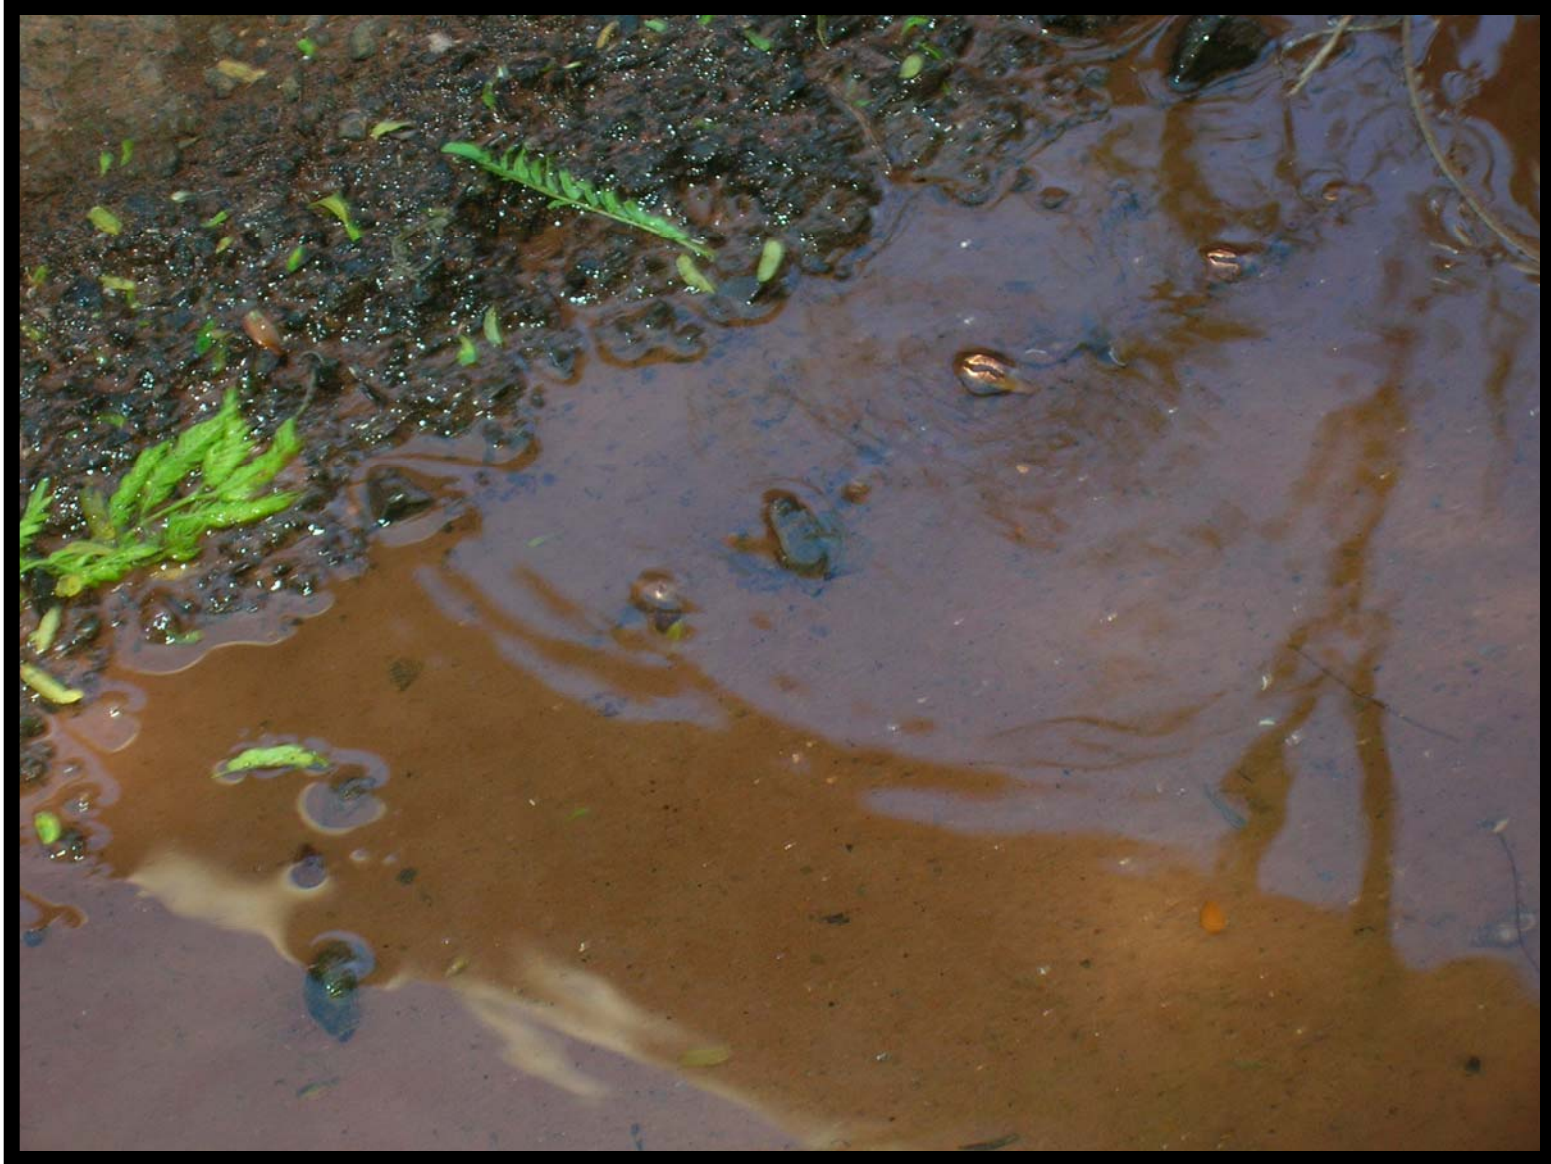
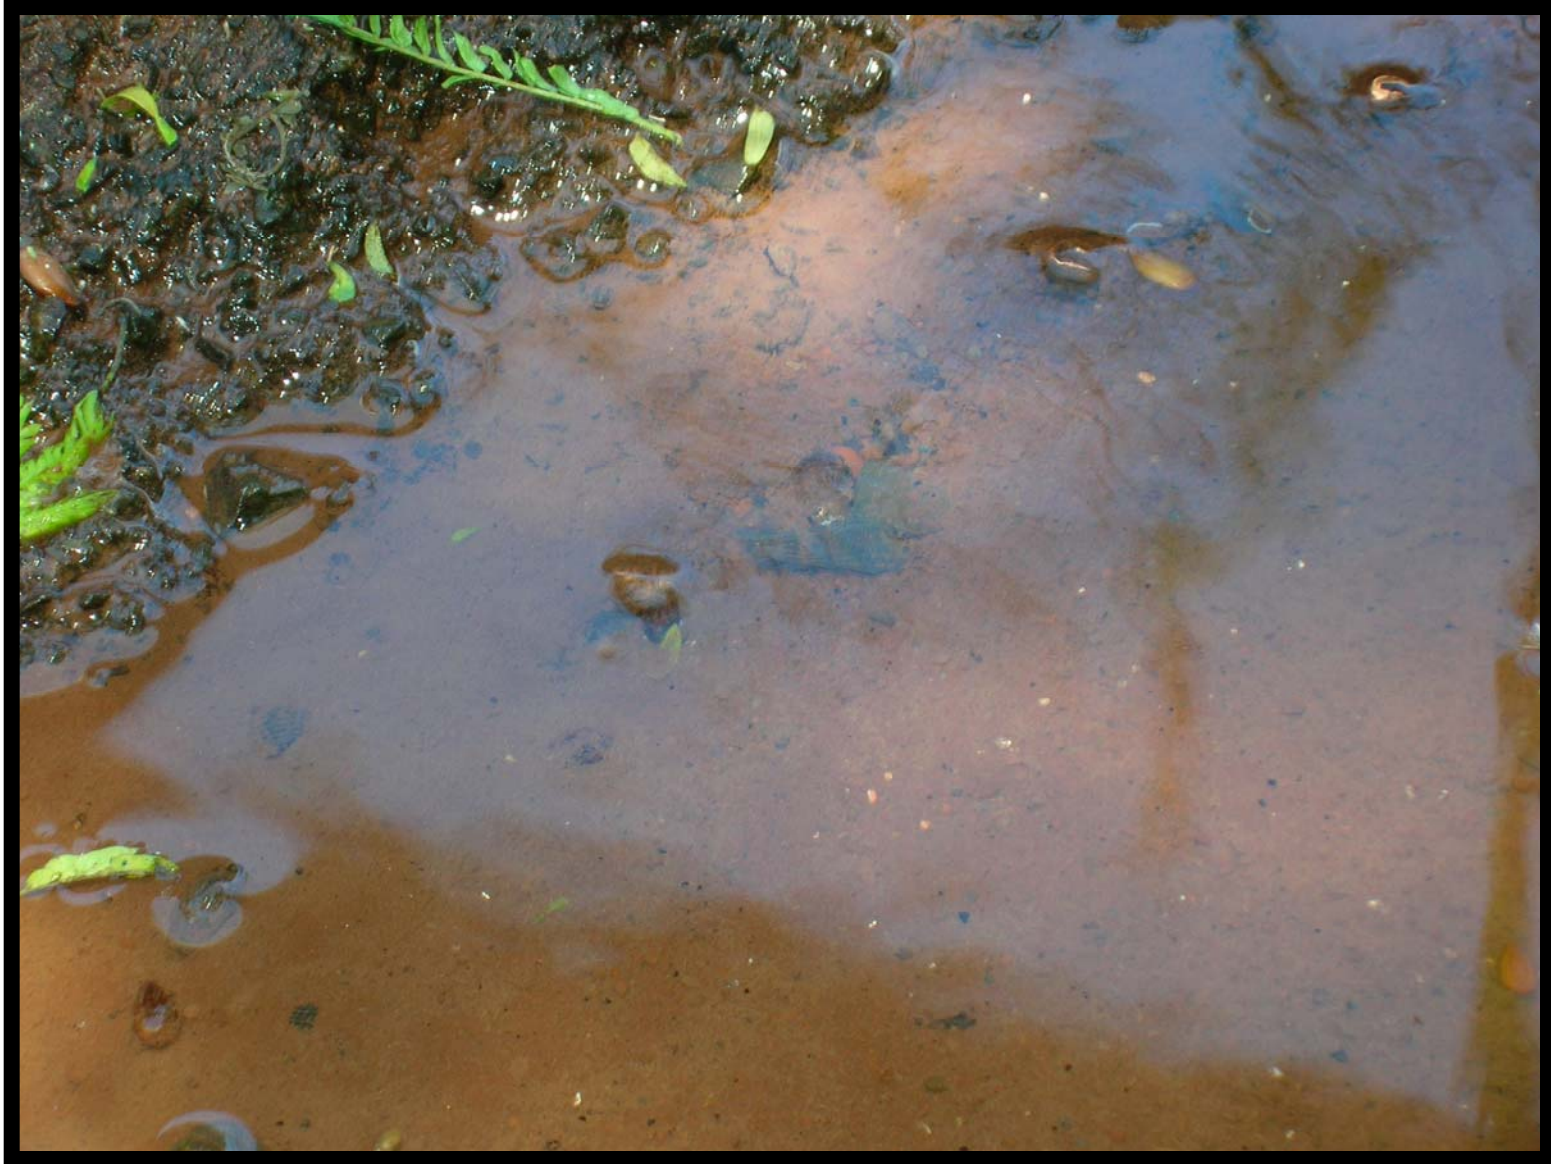
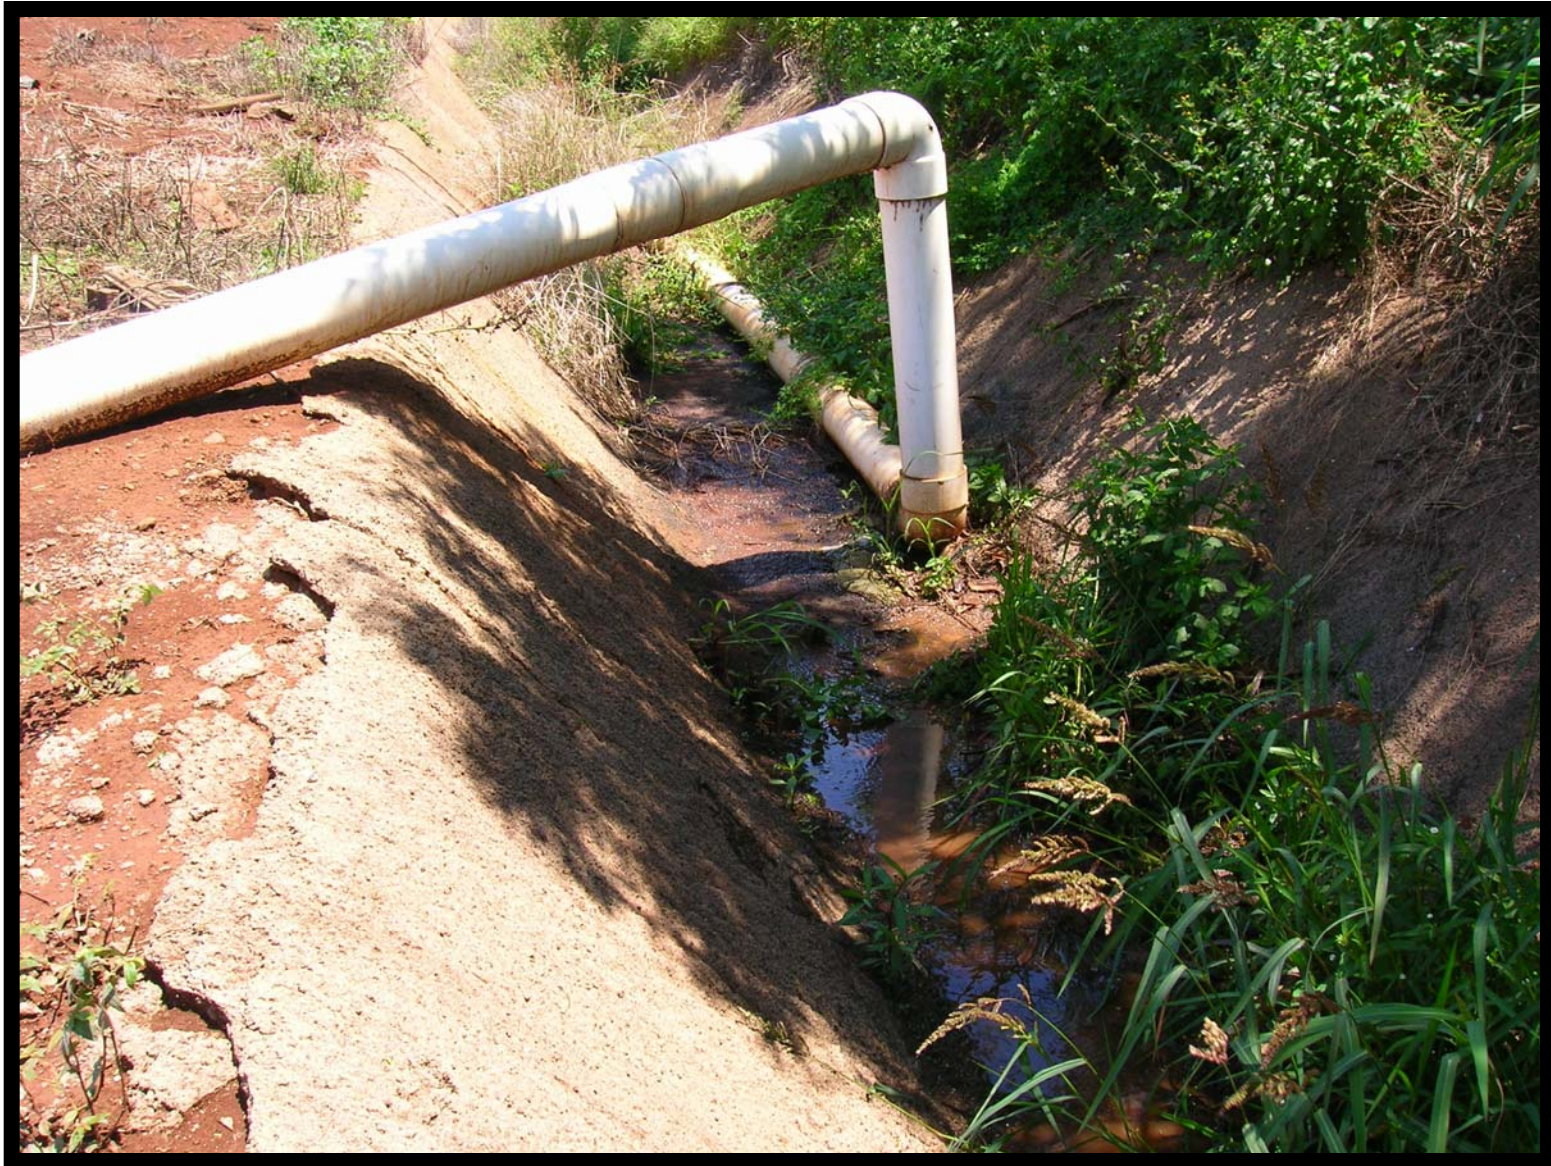
088 seep - Small seep in downstream concrete ditch

088 seep 2 - Small seep in downstream concrete ditch

088 seep 3 - Small seep in downstream concrete ditch

Seepage: Seep Spot Number 1☐ Green Vegetation ☐ Wet or Muddy Ground ☐ Ponding Water ☐ Not Visible ☐ None Observed☒ Flowing, Description: 1 GAL/MIN Y- COMING FROM BOTTOM OF CONCRETE DITCH @ TOE.Water Clarity: ☒ Clear ☐ Some particles ☐ Muddy ☐ Other: _____

- ☒ h. Seepage/Ponding water was observed. Monitor and conduct further investigation to locate the source of water and extent of any possible hazardous or developing condition.

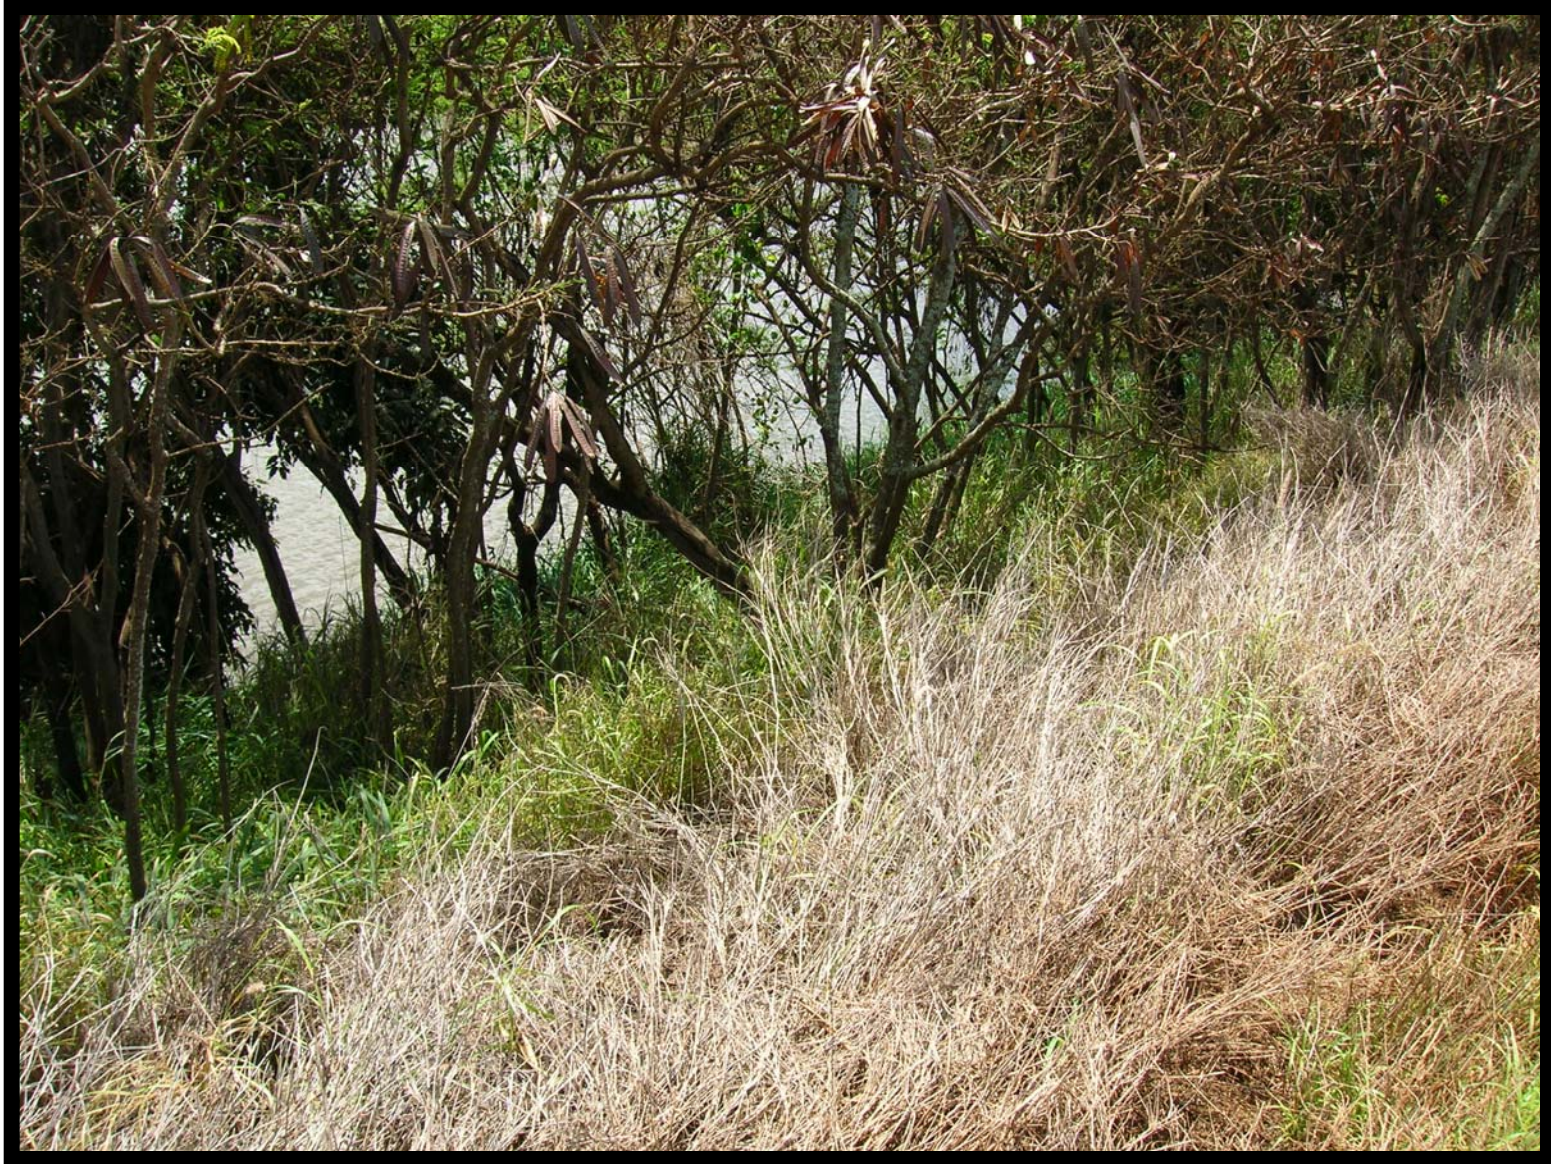
088 upstream slope

- a. The upstream slope appeared to be in fair to poor condition and requires corrective action.
- b. The upstream slope was not visible due to high grass and bush vegetation. Clear high vegetation and maintain low to enable easy visual inspection.
- c. Tree(s) were observed on the dam embankment. Trees have been identified as the probably cause of piping failures, and can possibly cause sever damage to the embankment if they are uprooted during a high winds. Corrective action is required to remove the tree hazards from the dam. Acceptable remedies include removal of the tree and its root structure down to a 2" diameter and reconstructing the damaged embankment section. All repair work shall be accomplished as per the requirements of licensed geotechnical or structural engineer. Routinely monitor the damaged area for signs of settlement and seepage.

- ☐ h. A sinkhole was observed on the slope, which requires further investigation to determine the underlining cause. Repair and monitor the area.
- ☒ i. The upstream slope was not visible due to high grass and bush vegetation. Clear high vegetation and maintain low to enable easy visual inspection.

- ☒ j. Tree(s) were observed on the dam embankment. Trees have been identified as the probably cause of piping failures, and can possibly cause sever damage to the embankment if they are uprooted during a high winds. Corrective action is required to remove the tree hazards from the dam. Acceptable remedies include removal of the tree and its root structure down to a 2" diameter and reconstructing the damaged embankment section. All repair work shall be accomplished as per the requirements of licensed geotechnical or structural engineer. Routinely monitor the damaged area for signs of settlement and seepage.
